# Manhole Inspection Summary

Manhole # S06YY1014MH

**Location** Address: **3900 CLARINTH RD**

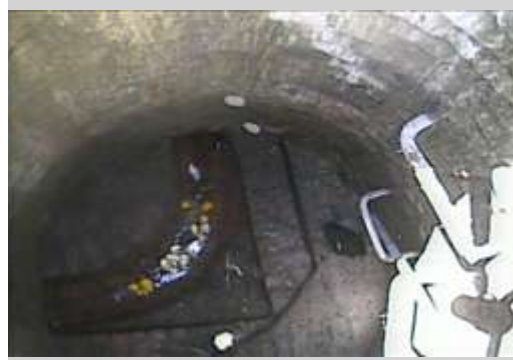
Top View

Adjustment and Corbel infiltration. Bench debris.

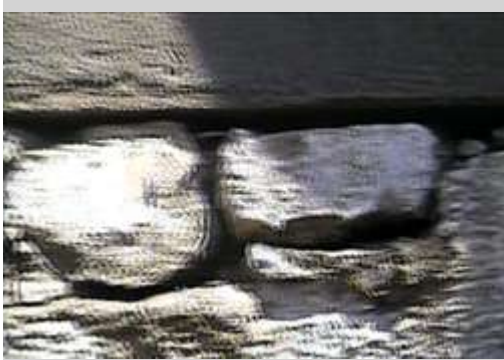
Defect

Adjustment deterioration and loose brick.  
Adjustment infiltration.

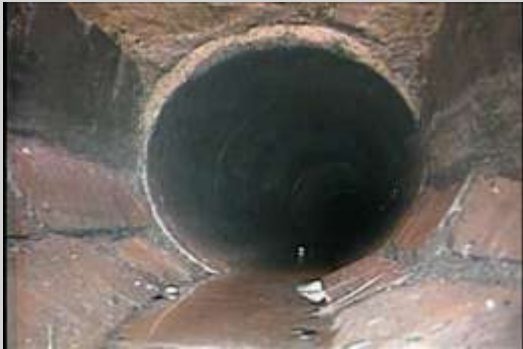
### 8 in. Circular Gravity Sewer Pipe Out @ 12 O'Clock

Invert Depth: **7.40** (ft.) Flow Characteristics: **Slow**

Deposits: ☒ None ☐ Mud ☐ Sludge ☐ Debris ☐ Grease

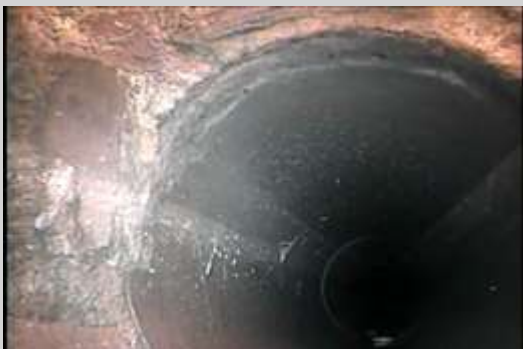
### 8 in. Circular Gravity Sewer Pipe In @ 9 O'Clock

Comments **The I9 pipe picture shows grease deposits in the Channel and inside of the pipe. This MH is located in the alley between Clarinth Rd and Brookhill Rd.**

Deposits: ☐ None ☐ Mud ☐ Sludge ☐ Debris ☒ Grease

Silt Depth: **0** (in.) Deposits Extent: **Light**
